TENDER OPPORTUNITY

The Village of Debden invites tenders to reshingle the roof of the **Debden Centennial Hall** located at #120 Main Street Debden and the **Debden Community Center** located at #204 2nd Avenue East Debden, SK.

Location #1

Location #2

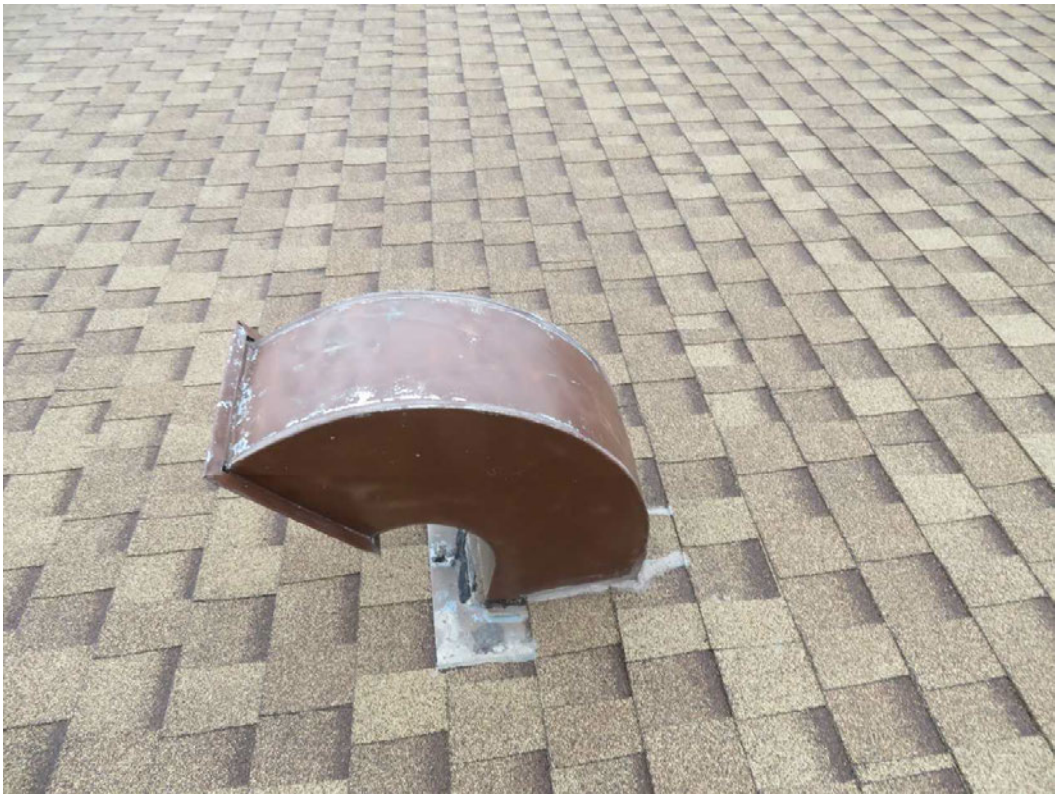
27-RIGHT SLOPE

INDUSTRIAL EXHAUST VENTS ON
ROOF APPEAR NOT DAMAGED

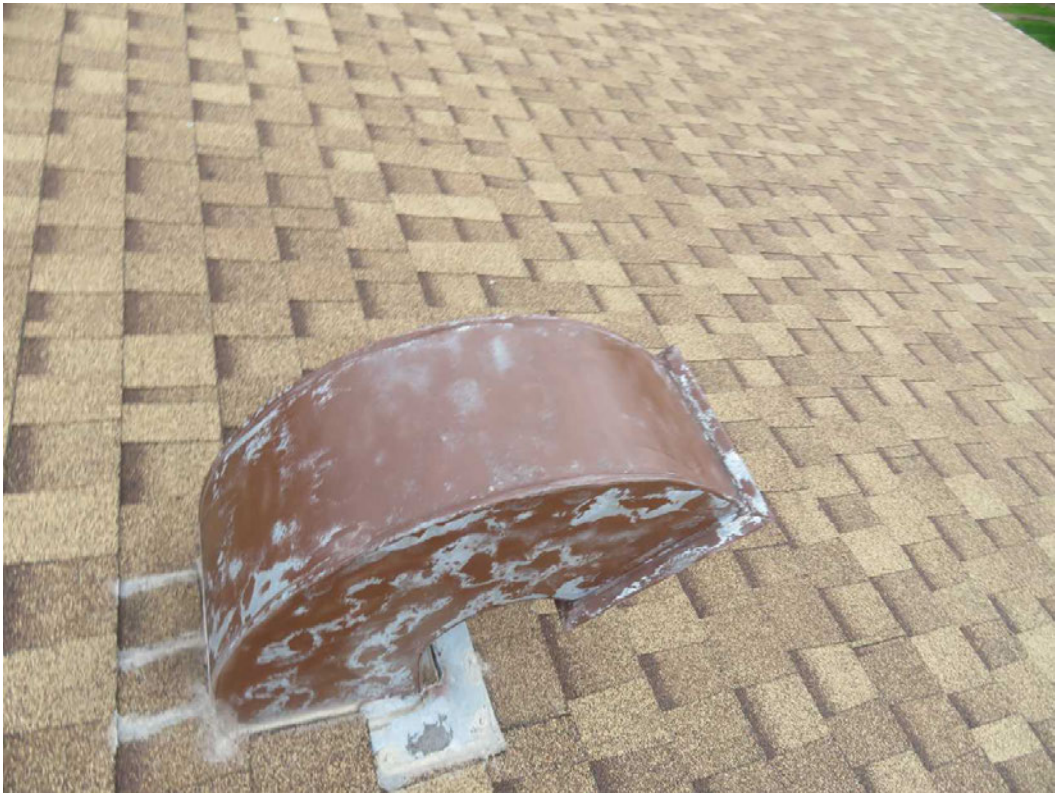
28-RIGHT SLOPE

INDUSTRIAL EXHAUST VENTS ON
ROOF APPEAR NOT DAMAGED

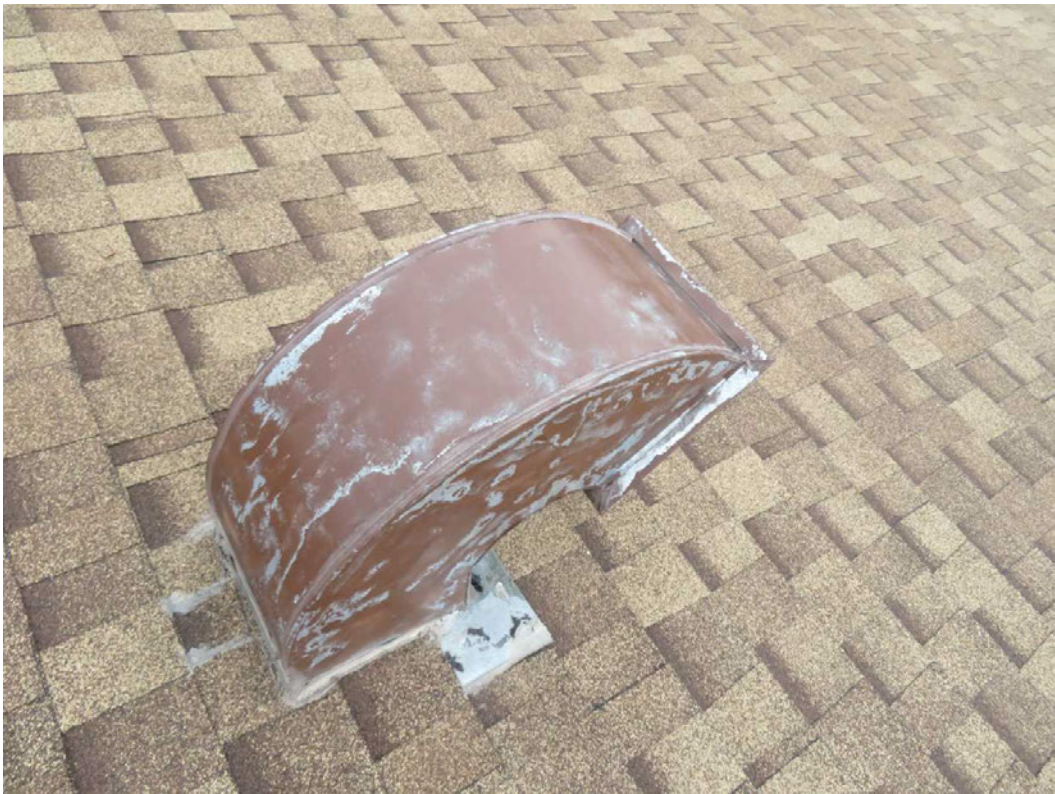
29-RIGHT SLOPE

INDUSTRIAL EXHAUST VENTS ON
ROOF APPEAR NOT DAMAGED

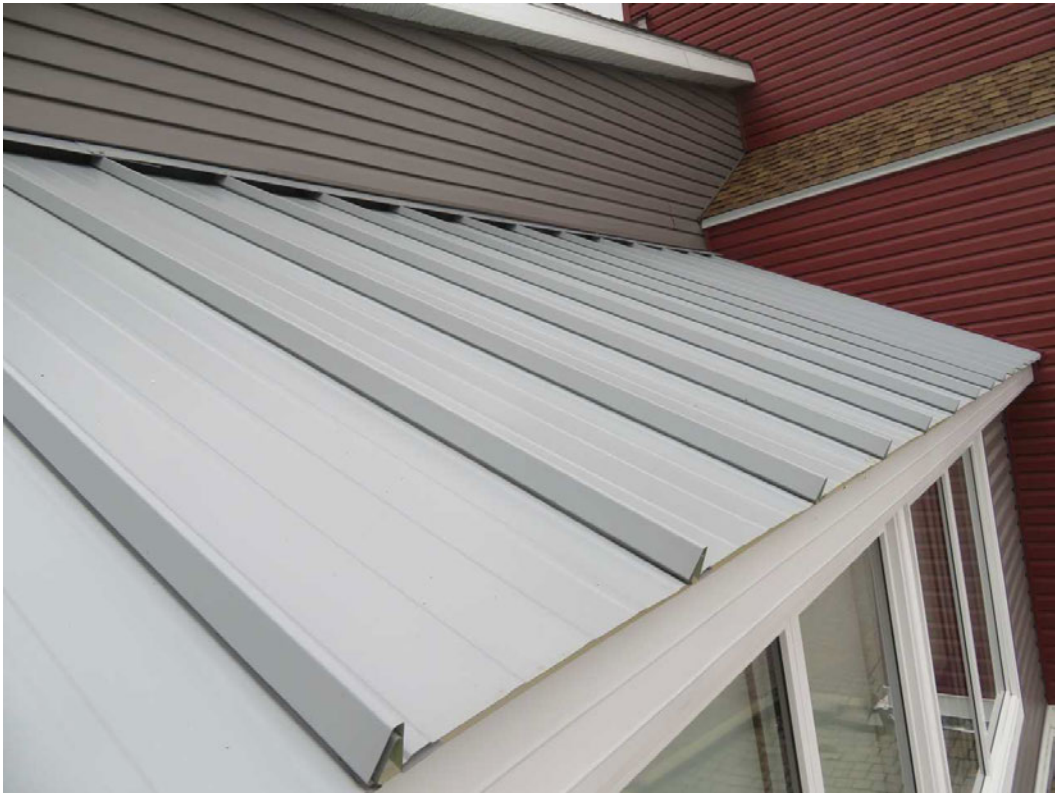
30-FRONT SLOPE

FRONT SLOPE HAS NO VISIBLE
HAIL DAMAGE

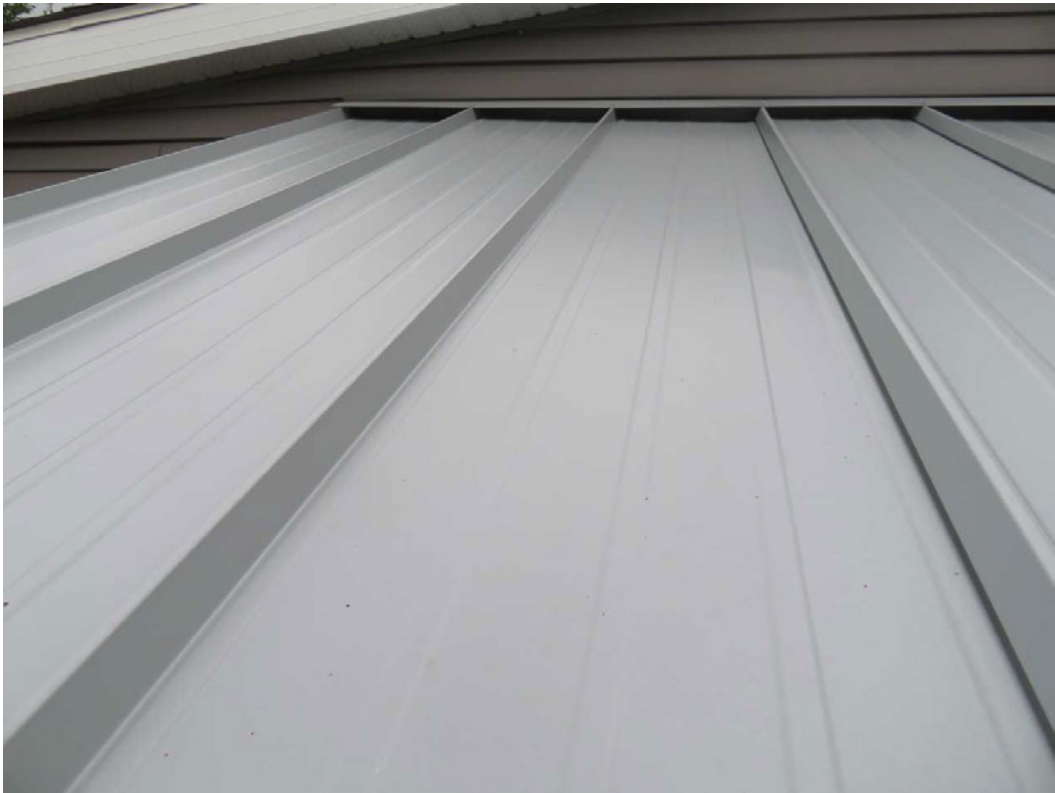
32-FRONT SLOPE

FRONT SLOPE HAS NO VISIBLE
HAIL DAMAGE

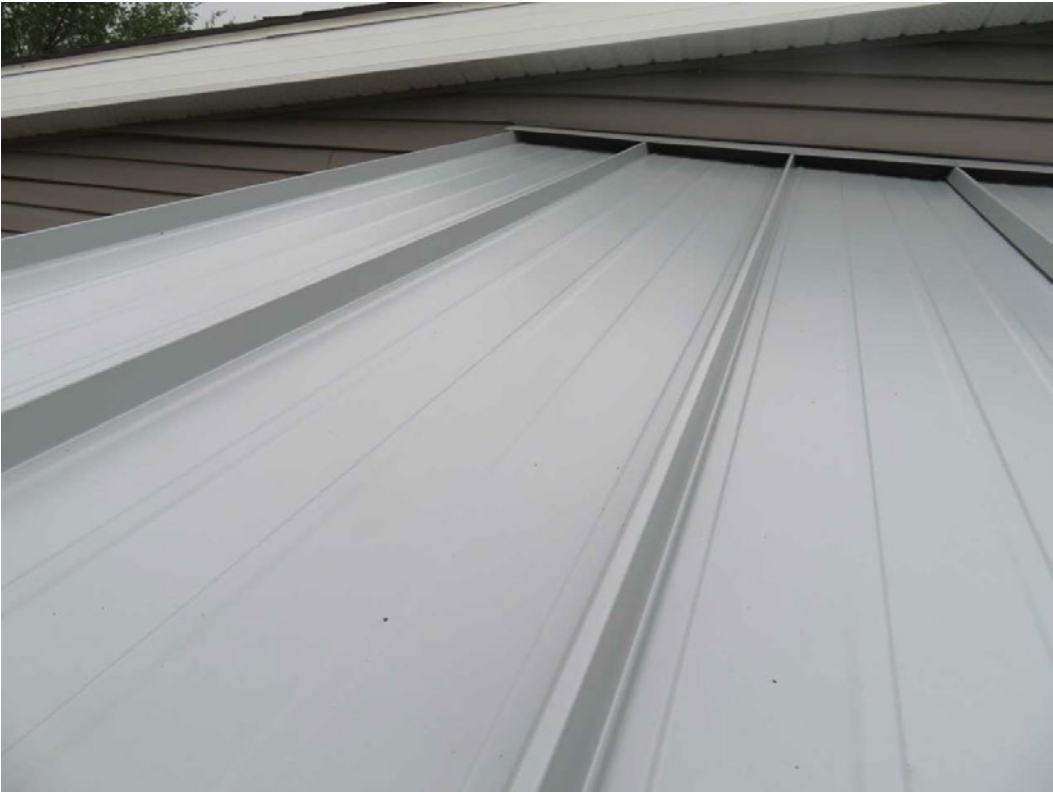
33-FRONT SLOPE

FRONT SLOPE HAS NO VISIBLE
HAIL DAMAGE

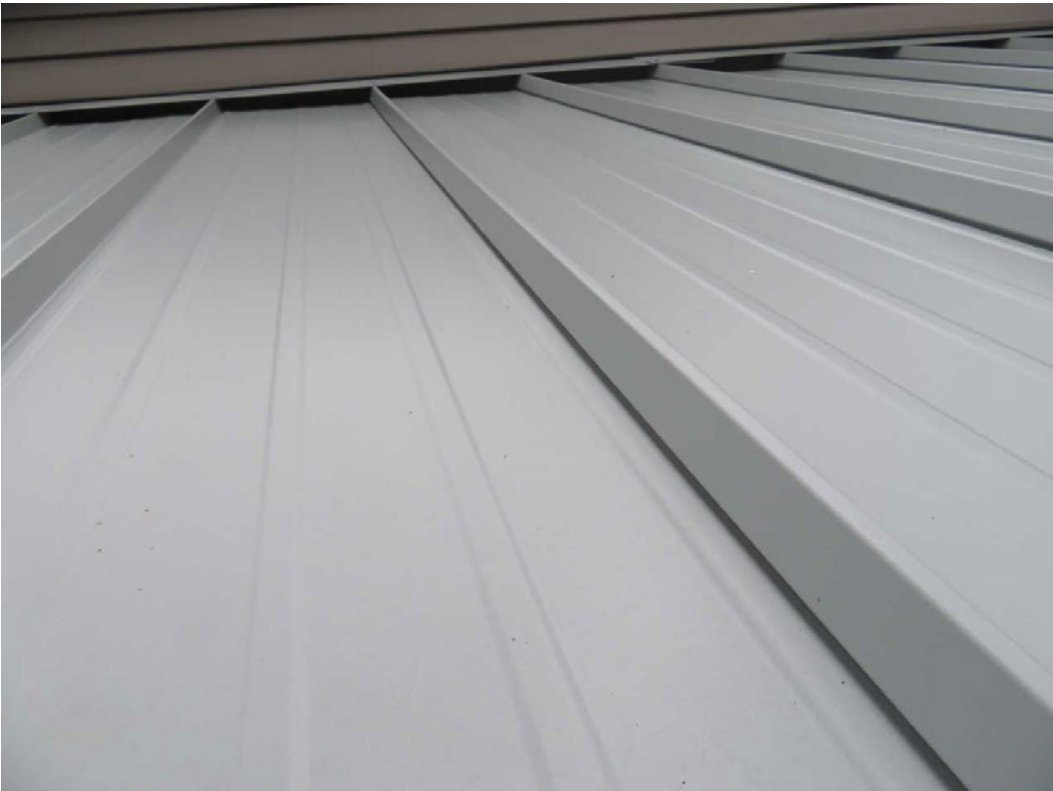
34-FRONT SLOPE

FRONT SLOPE HAS NO VISIBLE
HAIL DAMAGE

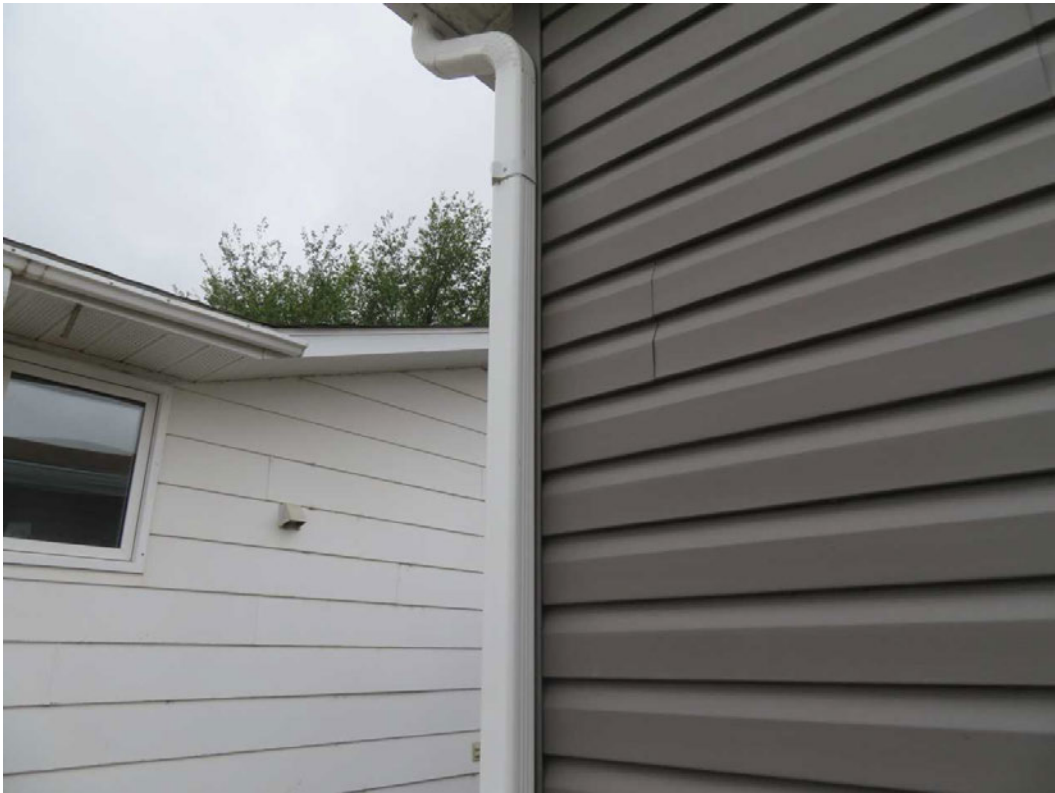
40-FRONT ELEVATION

FRONT ELEVATION DOWNSPOUT
HAS HAIL DAMAGE

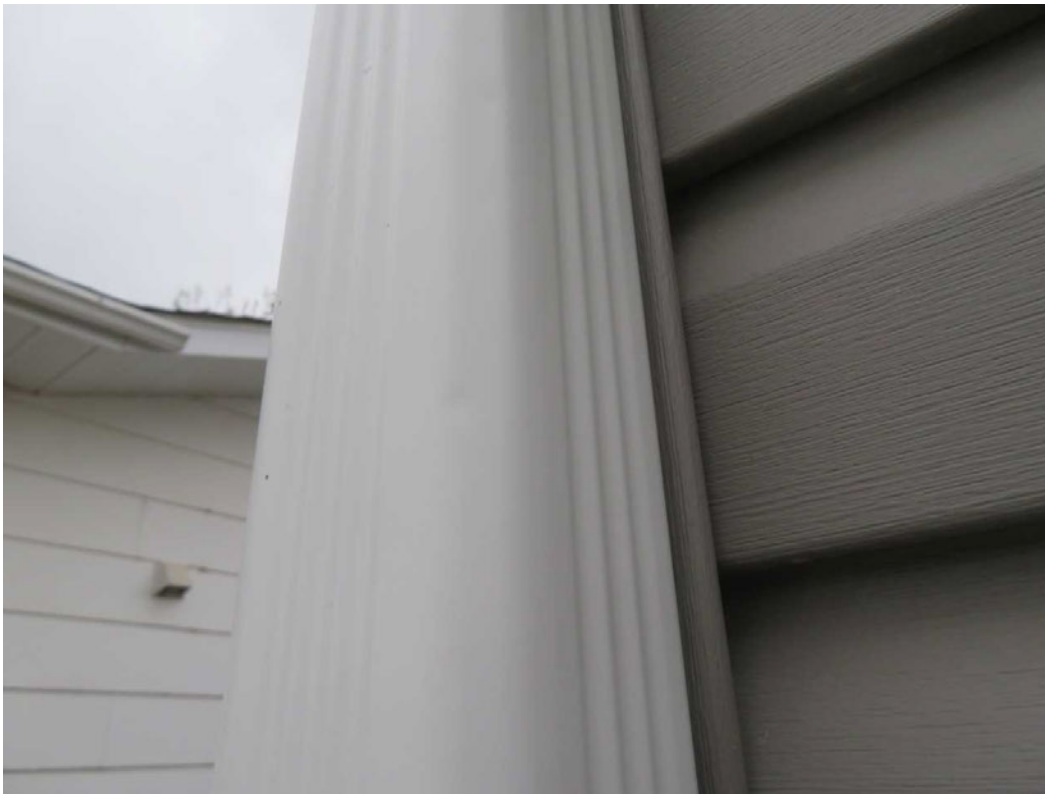
41-FRONT ELEVATION

FRONT ELEVATION DOWNSPOUT
HAS HAIL DAMAGE

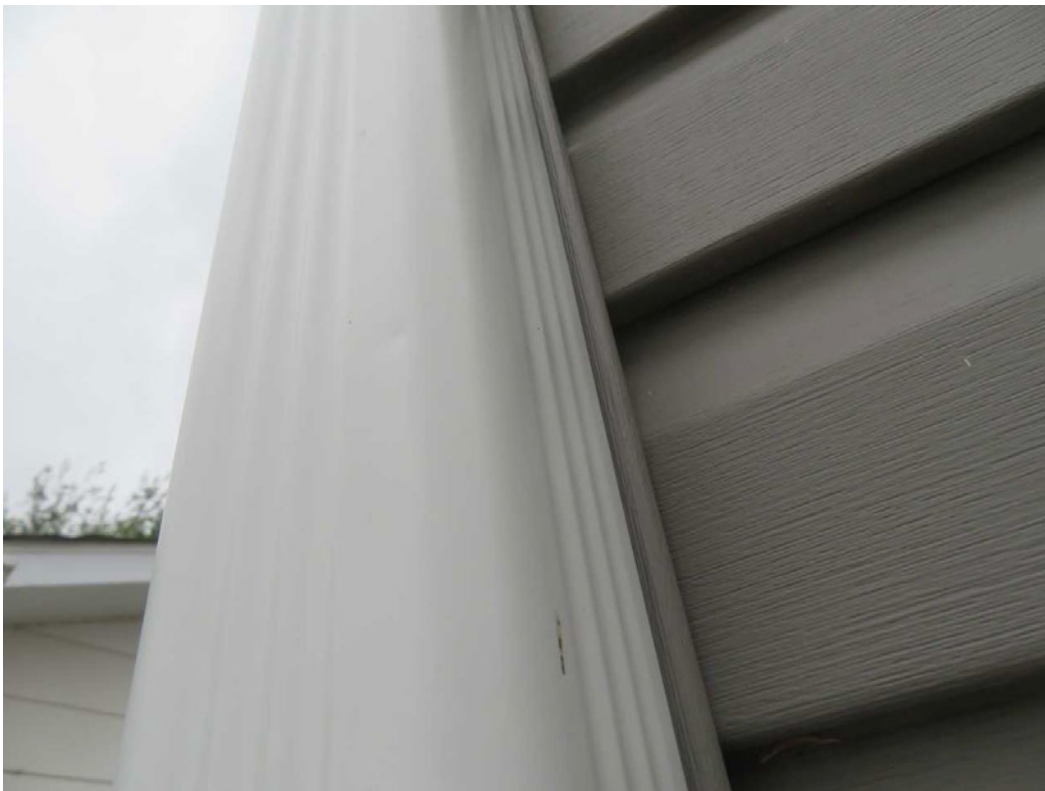
42-FRONT ELEVATION

FRONT ELEVATION DOWNSPOUT
HAS HAIL DAMAGE

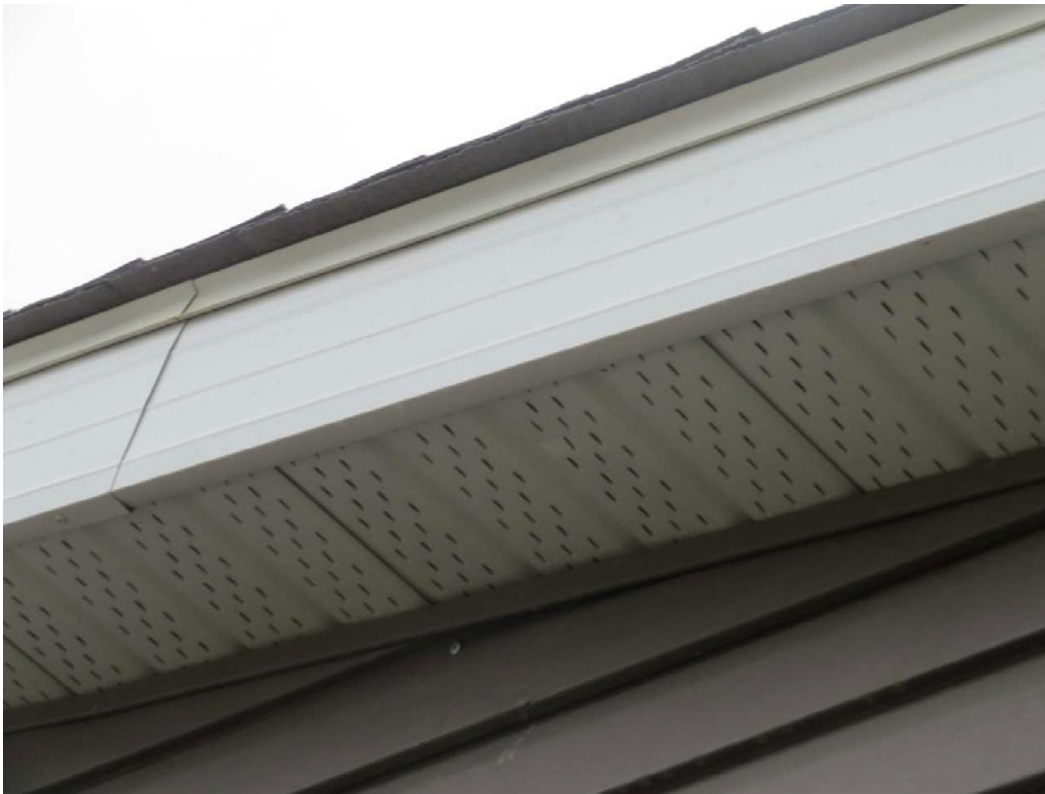
45-FRONT ELEVATION

REMAINING ITEMS ON
ELEVATION HAVE NO VISIBLE
HAIL DAMAGE

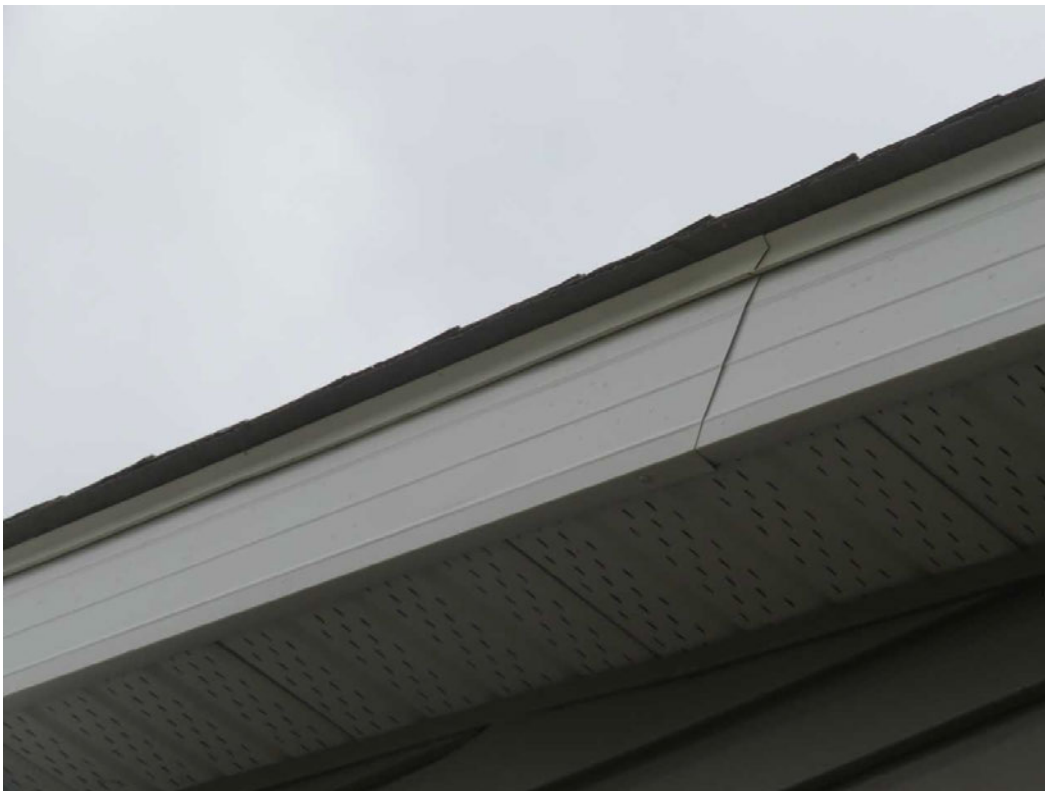
46-FRONT ELEVATION

REMAINING ITEMS ON
ELEVATION HAVE NO VISIBLE
HAIL DAMAGE

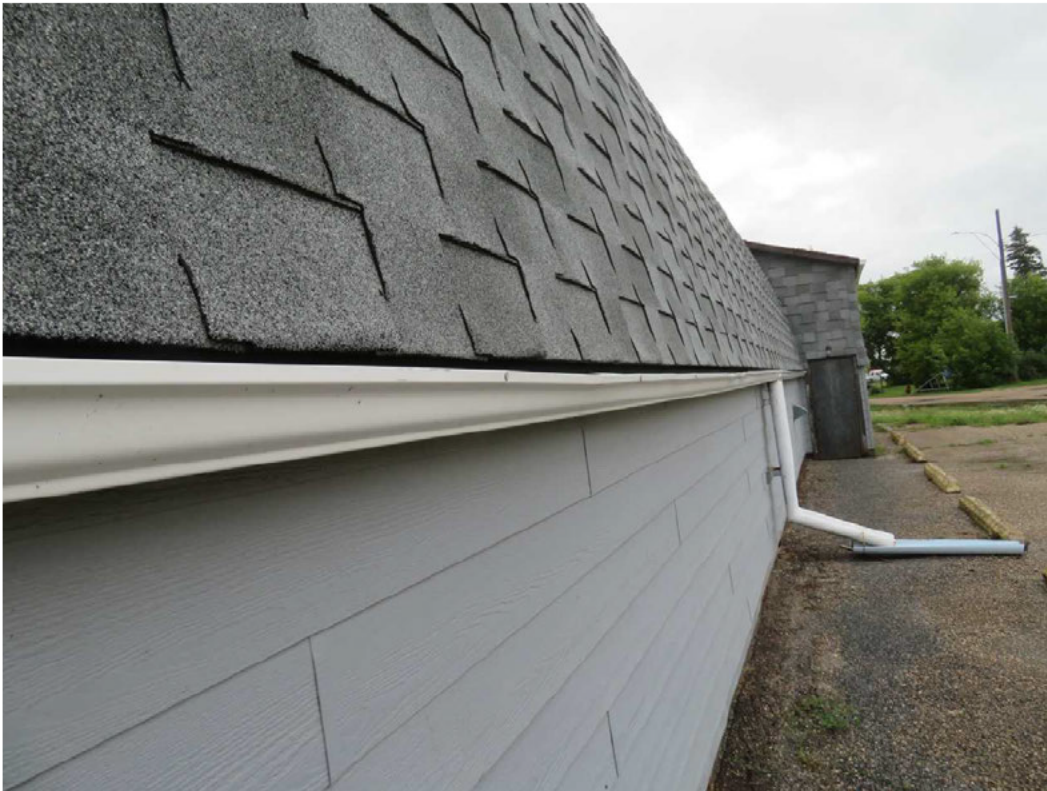
32-FRONT ELEVATION

FRONT ELEVATION GUTTER HAS
HAIL DAMAGE

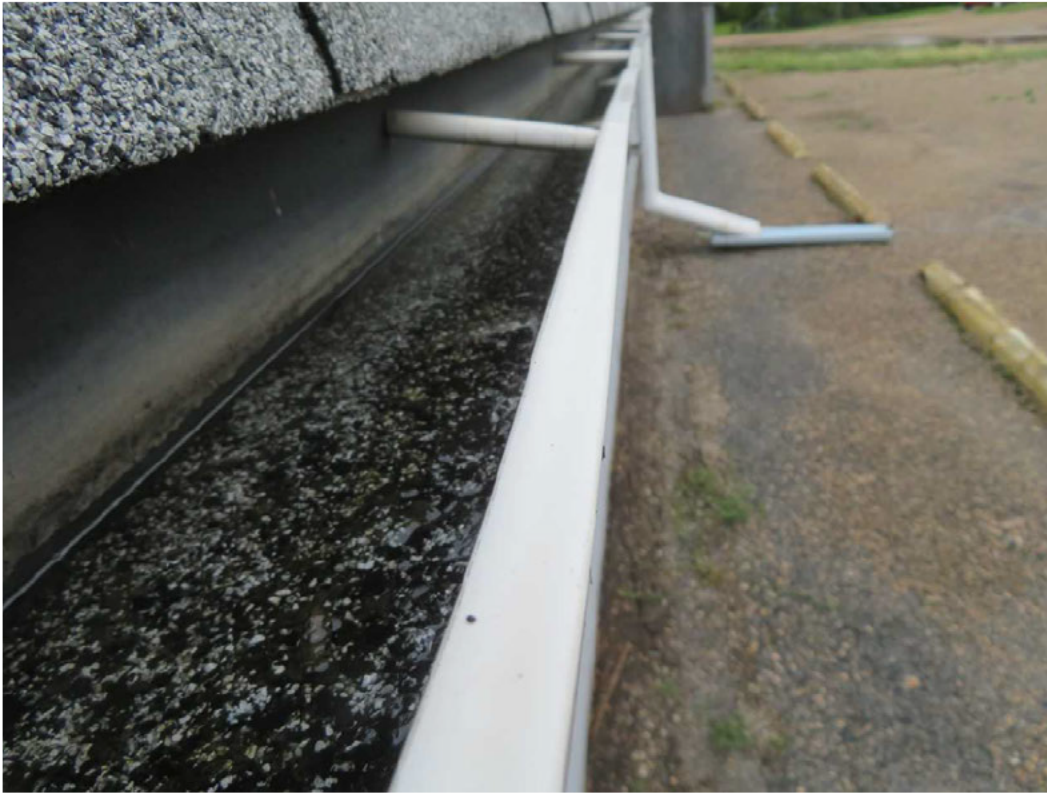
35-FRONT ELEVATION

FRONT ELEVATION GUTTER HAS
HAIL DAMAGE

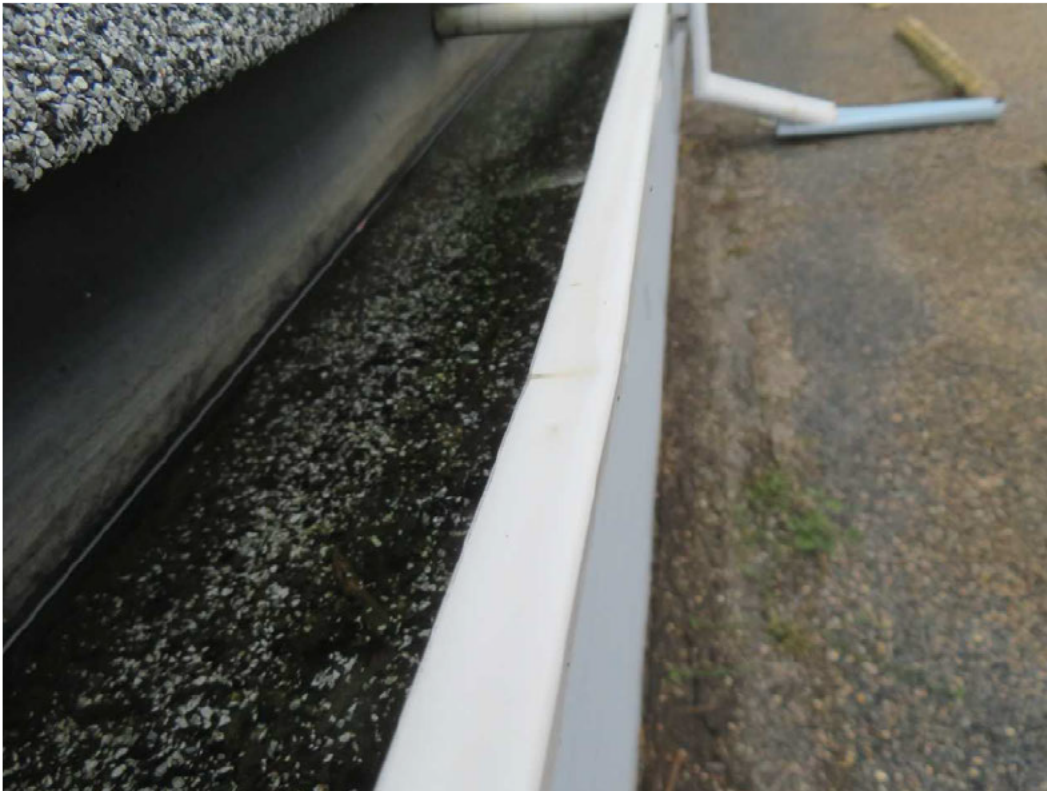
36-FRONT ELEVATION

FRONT ELEVATION GUTTER HAS
HAIL DAMAGE

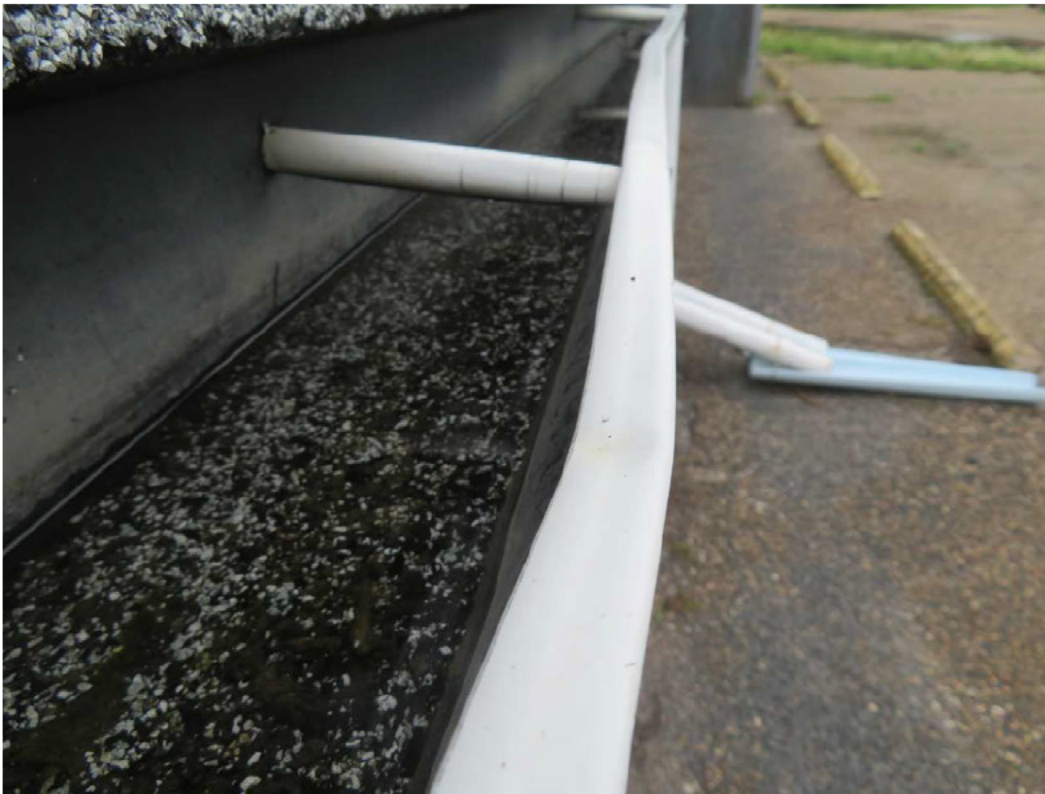
37-FRONT ELEVATION

FRONT ELEVATION GUTTER HAS
HAIL DAMAGE

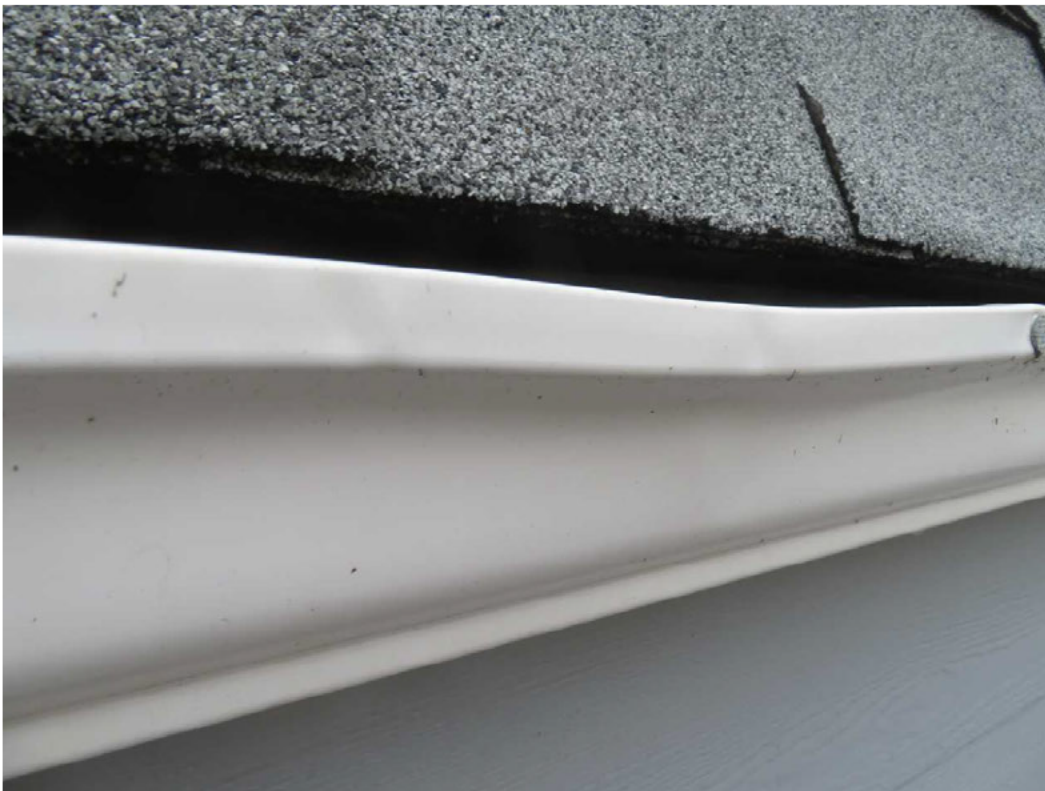
38-FRONT ELEVATION

FRONT ELEVATION GUTTER HAS
HAIL DAMAGE

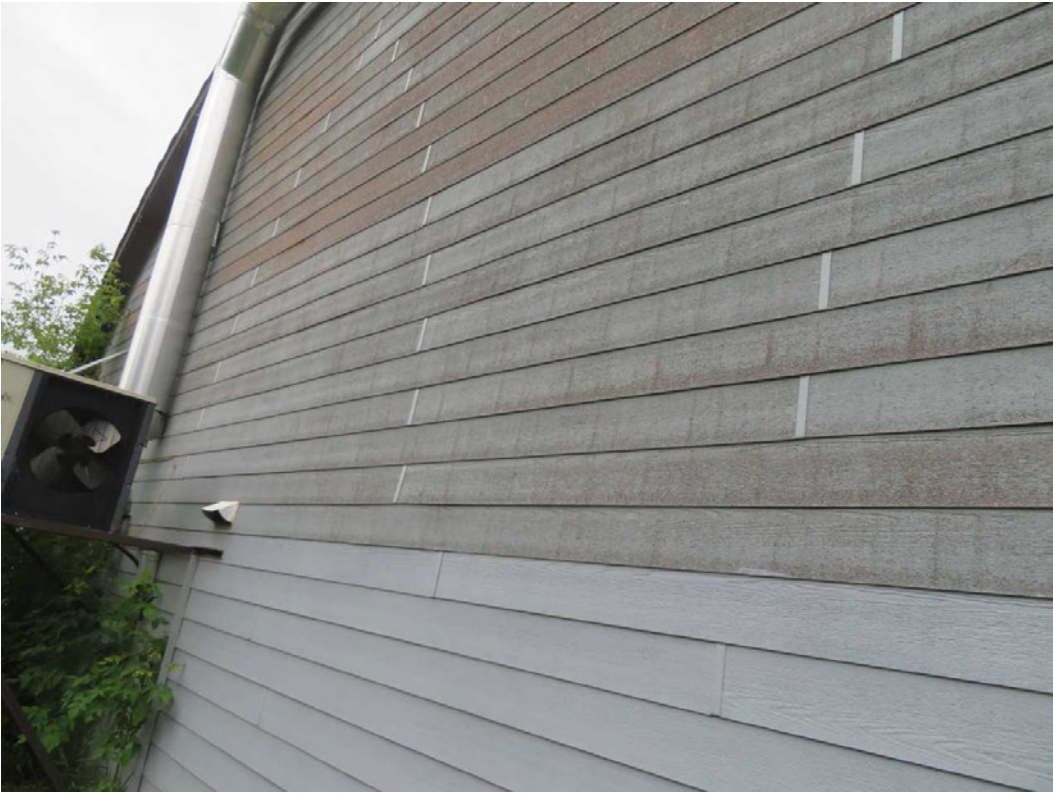
[REDACTED]-RIGHT ELEVATION

RIGHT ELEVATION HAS NO
VISIBLE HAIL DAMAGE

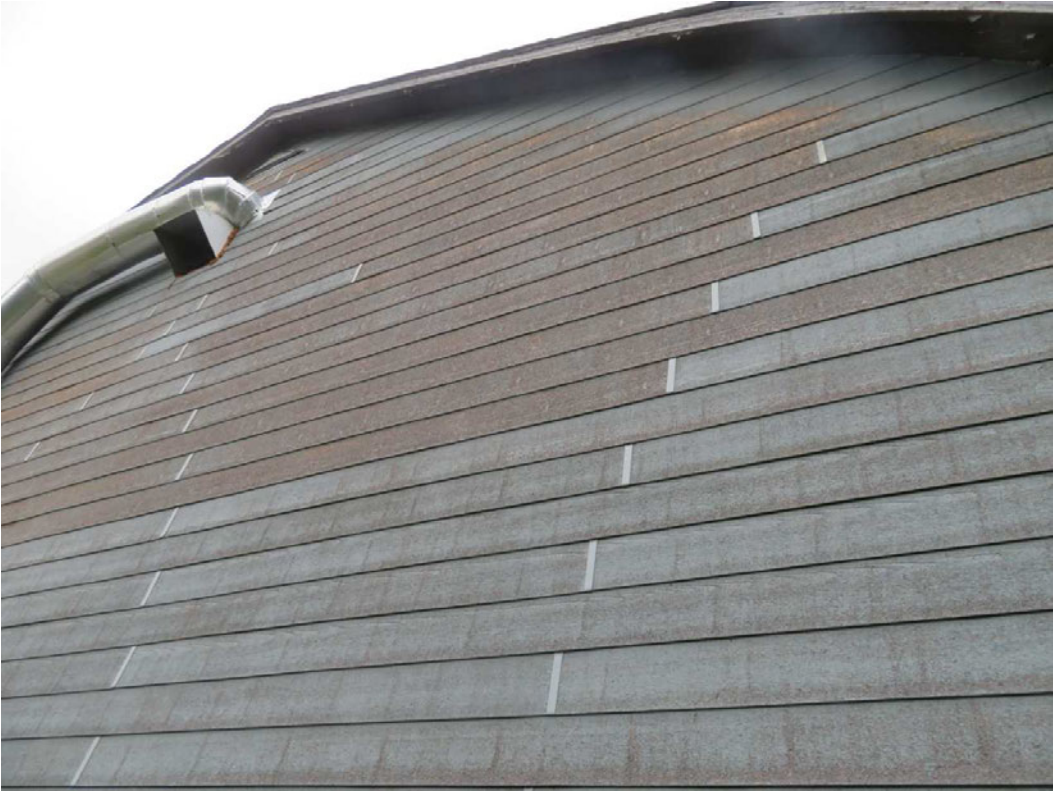
48-RIGHT ELEVATION

RIGHT ELEVATION HAS NO
VISIBLE HAIL DAMAGE

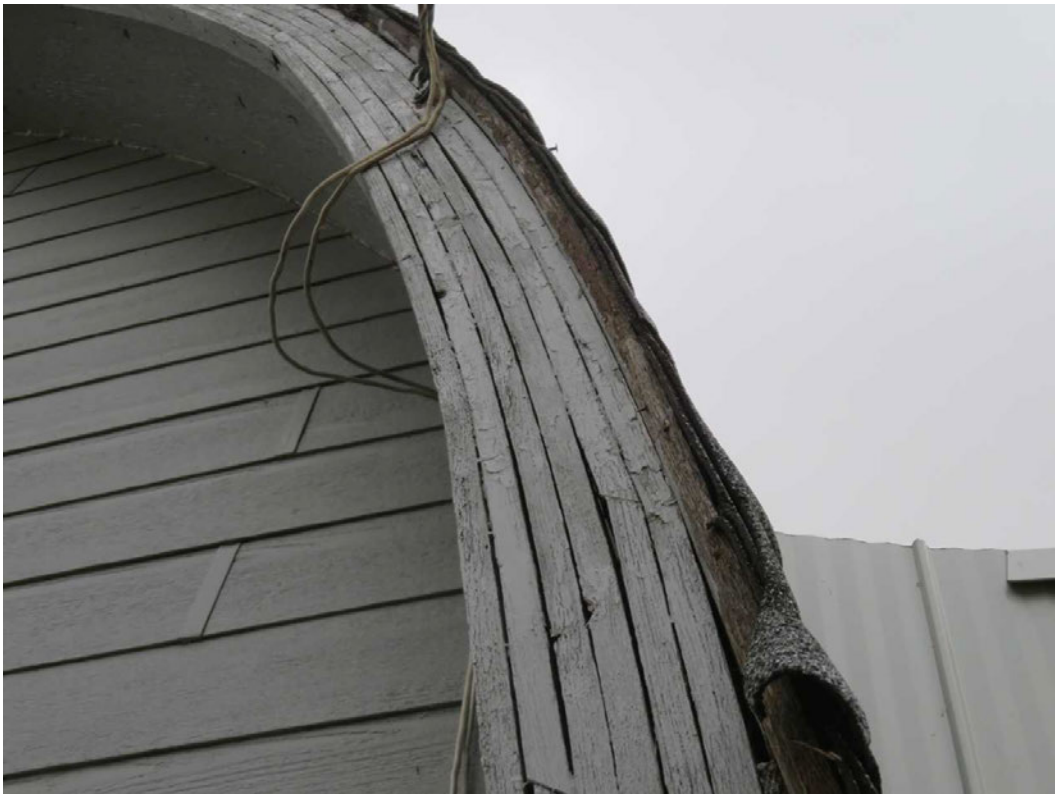
71-LEFT ELEVATION

LEFT ELEVATION HAS NO VISIBLE
HAIL DAMAGE
